ABIQUIU DAM AND RESERVOIR

**RIO GRANDE BASIN, RIO CHAMA
NEW MEXICO**

EMBANKMENT CRITERIA AND PERFORMANCE REPORT

APR 1987

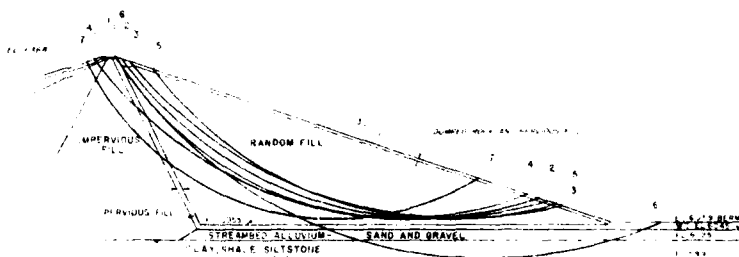
LOCATION OF TRIAL FAILURE ARCS
MAXIMUM EMBANKMENT SECTION

a. Design Studies. The analyses of embankment stability for the construction condition are presented in DM No. 7 for the original design. Plate 30 shows a summary of the arcs investigated and the assumptions used in the analyses. The construction condition was defined as the condition at the end of a 3-year construction period before any pore pressure induced during placement of random and impervious fill had time to dissipate. Tailwater elevation was assumed to be streambed level with no seepage through the embankment. The combined CD-CU shear strength envelope was used for trial arcs cutting the random fill 10 feet or more above the pervious stream bed blanket. A factor of safety of 1.22 was determined for the critical arc.

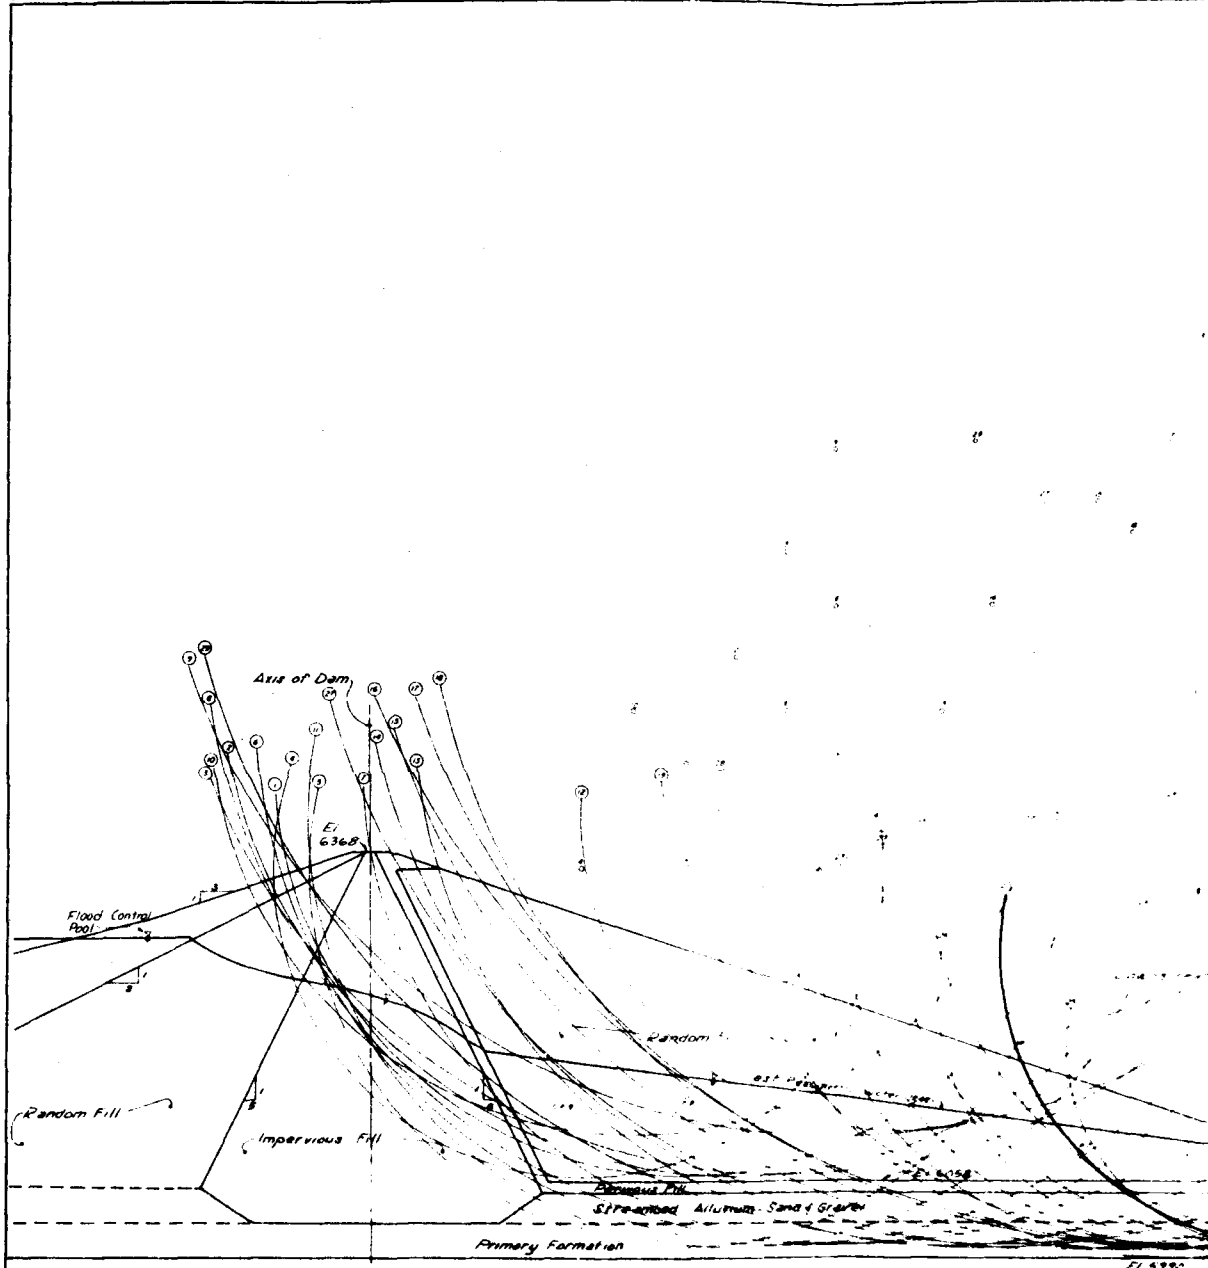
LOCATION OF TRAIL FAILURE ARCS
MAXIMUM EMBANKMENT SECTION

RIO GRANDE WATERSHED		RIO CHAMA, NEW MEXICO	
ABIQUIU DAM AND RESERVOIR			
STABILITY ANALYSIS-DOWNSTREAM SLOPE			
EARTHQUAKE CONDITION WITH SEEPAGE			
MANUAL SOLUTION			
US ARMY ENGINEER DISTRICT, ALBUQUERQUE, N.M.		FILE NO.	
TO ACCOMPANY PERIODIC INSPECTION REPORT NO. 1		DATE: OCT. 1974

Legend
Piezometer - P.B.
Note: Piezometer elevations shown are the
maximum elevations recorded during
the flood of Record June July Aug '73

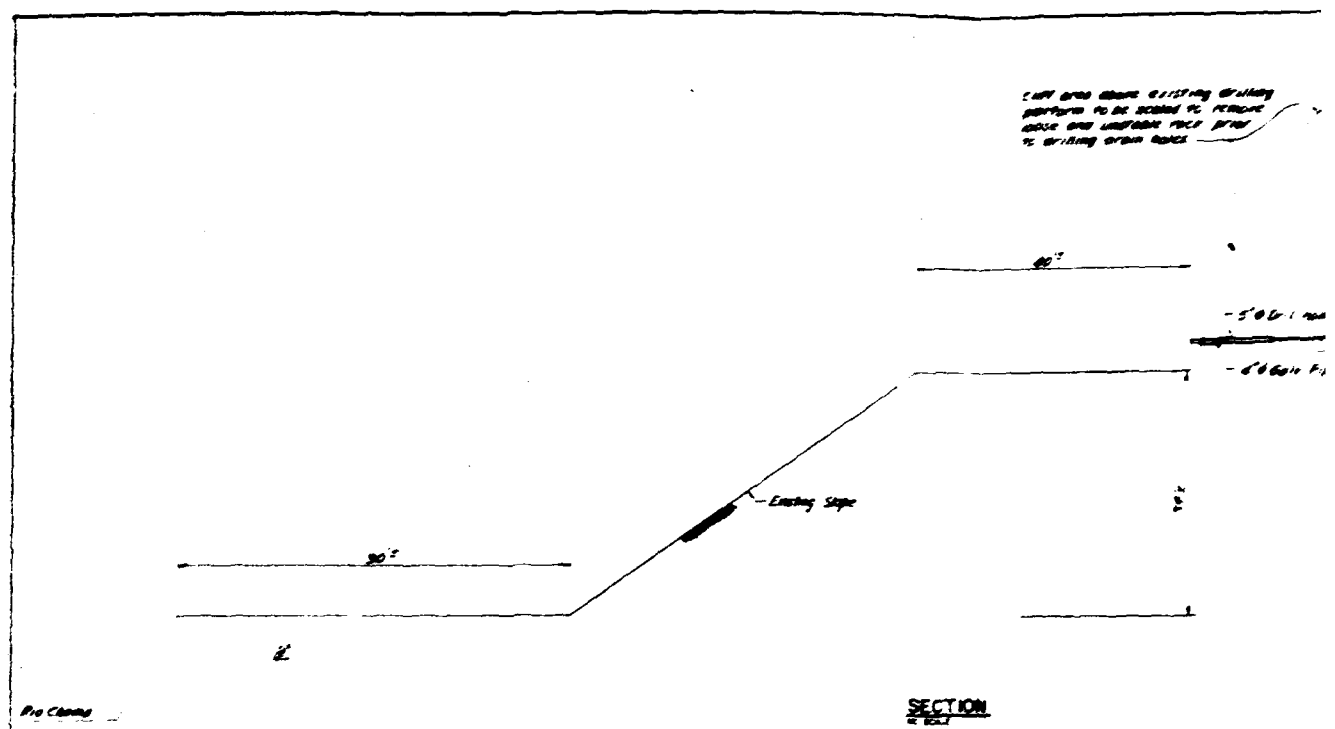
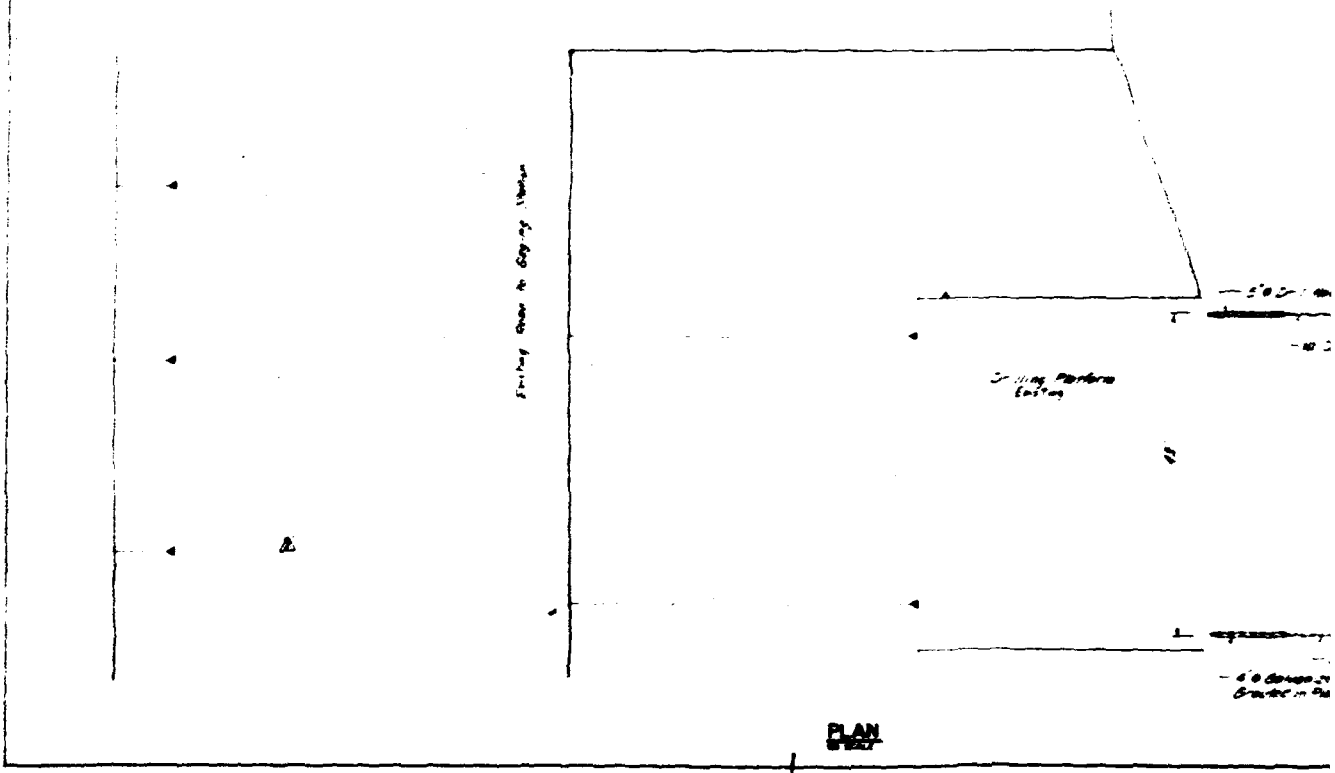
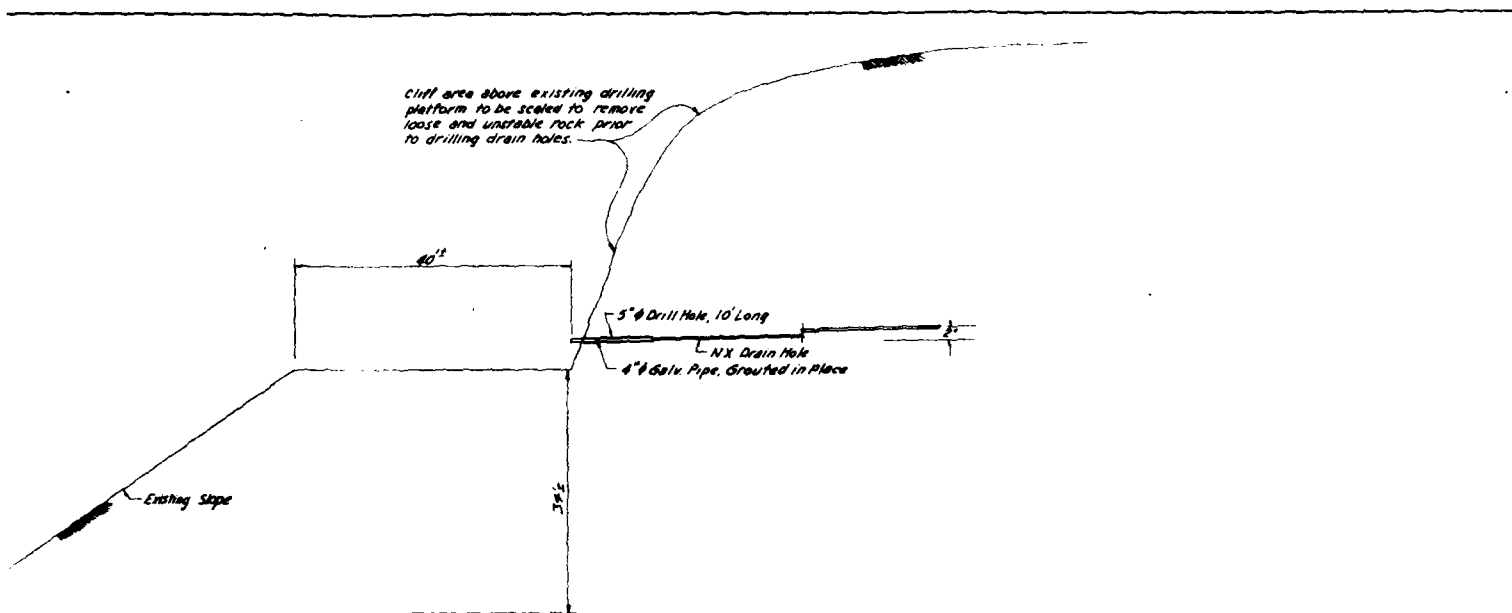
AS 200 DAM
SUPPLEMENTAL GROUTING
INSTRUMENT II
GROUTING DETAIL & CROSS SECTION

Cut area above existing drilling platform to be scaled to remove loose and unstable rock prior to drilling drain holes.

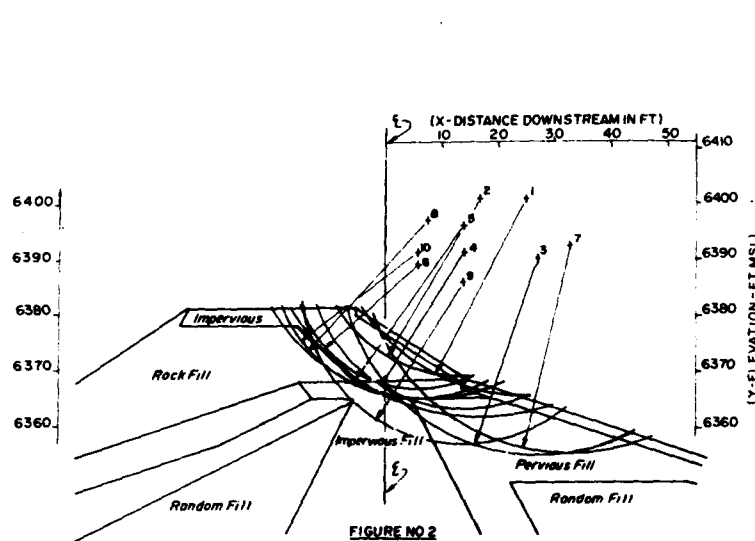
FIGURE NO. 2
EMBANKMENT SECTION FAILURE ARCS
BY COMPUTER SOLUTION

NOTE:
Additional arcs are shown on Plate 9, Fig. 1 downstream slope

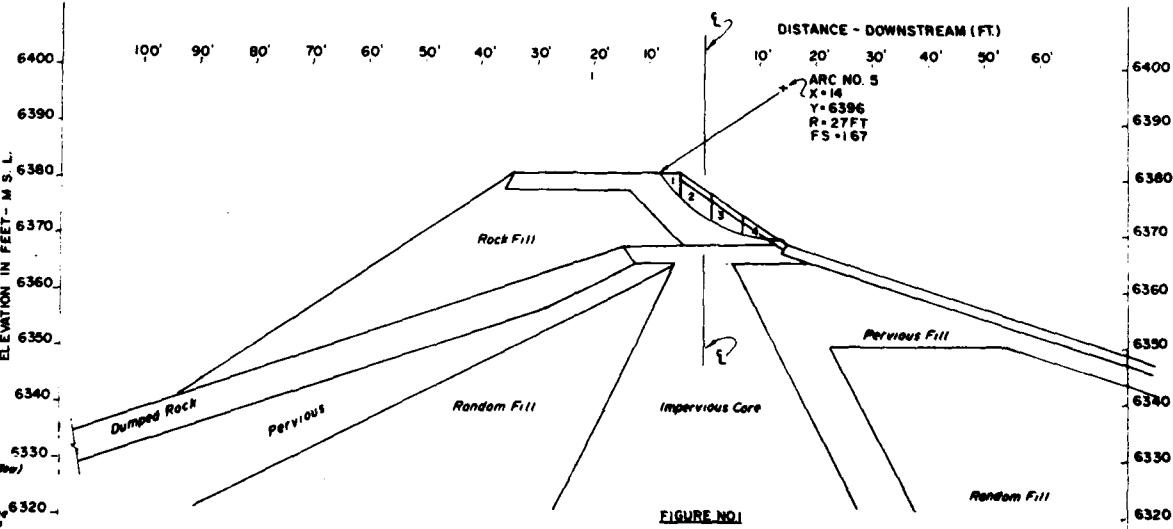
FIGURE NO. 1
EMBANKMENT SECTION
WITH FAILURE ARC NO. 5
MANUAL ANALYSIS

NOTE: This is not believed a realistic failure arc (shown) (Random failure arc NO 5 adopted as criterion for S-strength analysis and is verified by manual solution.)
 All failure arcs lying entirely in new construction imp. zone will have high P & S values Q-strength used in calculations (refer to arcs 1 and 5).
 Minimum factor of safety for computer analysis with P-strengths used in impervious material.
 Factor of safety obtained on computer by using record sample Q-strengths.
 Factor of safety obtained on computer by using record sample S-strengths.
 Factor of safety obtained on computer by using S-strengths selected for verifying embankment stability for end of construction case.
 NOTE: Arc numbers 1 thru 10 shown on Fig. 2
 Arc numbers 11 thru 20 are shown on plate 5, Fig. 1 downstream slope.
 The designation (S) is used to indicate the soil strengths used in the end of construction case analysis. This designation is used to differentiate between the record sample S-strengths and the S-strengths selected for use in the analysis.
